Navajo Abandoned Uranium Mine

Site Screen Report

King No. 2 AUM Site

March 2010

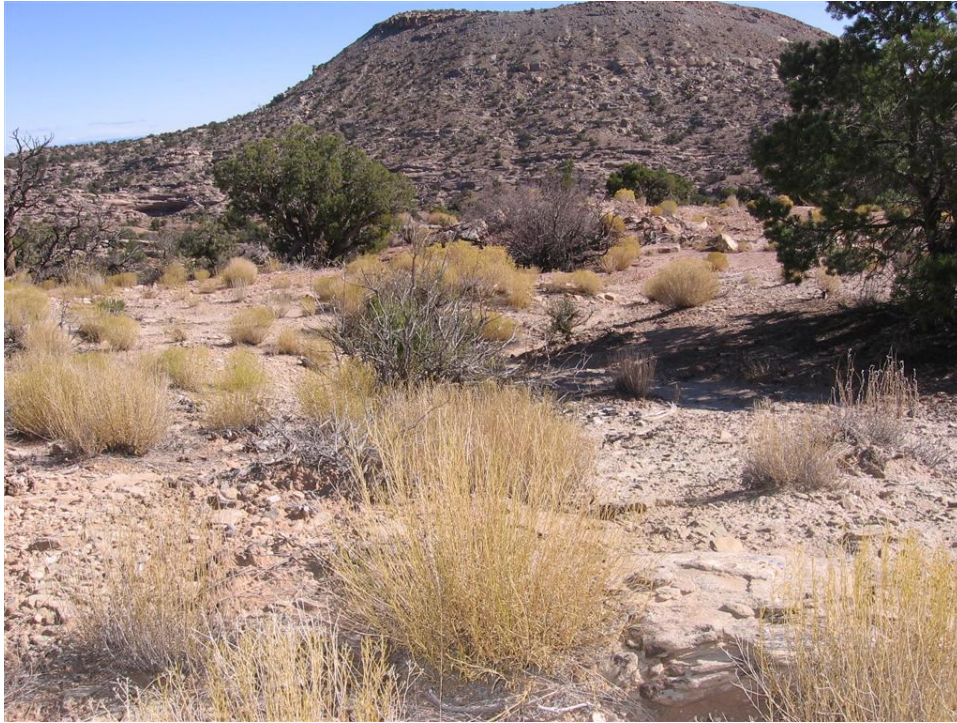
Photo 1. Mine site and drainage

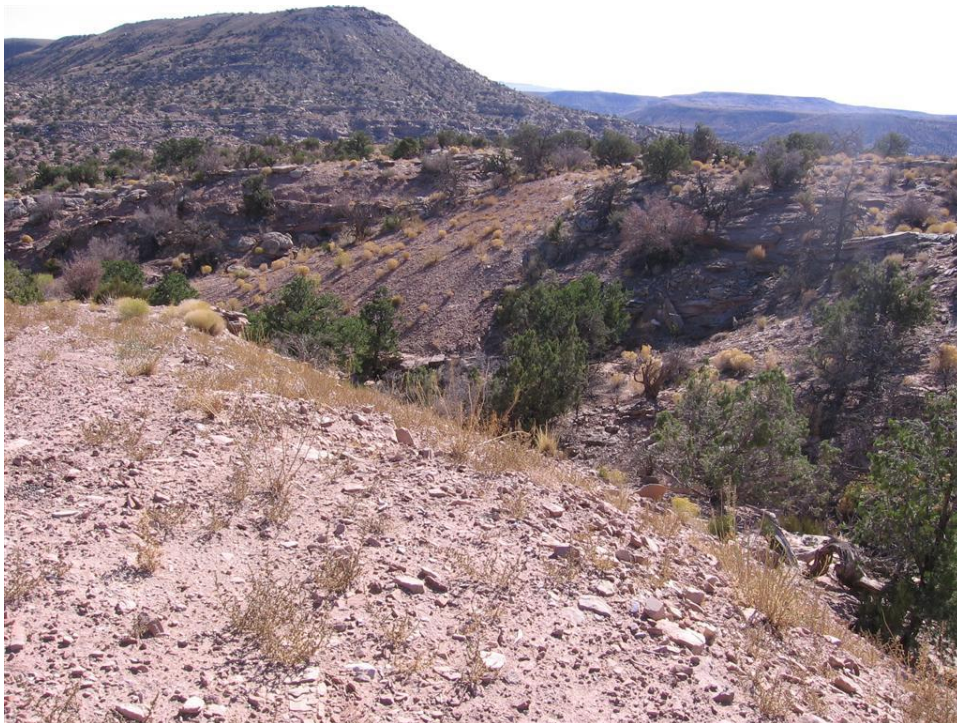
3 long waste piles, each 50' x 50', with a total estimated volume of 1,389 yd³

Photo 2. Waste pile

3 unreclaimed waste piles

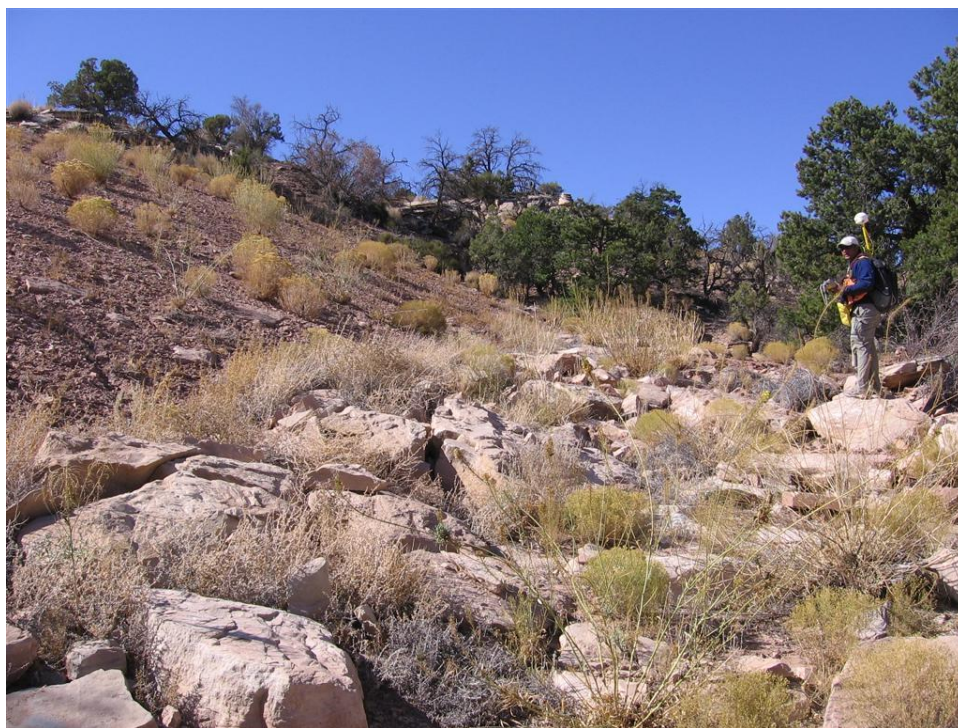
Photo 3. Waste rock

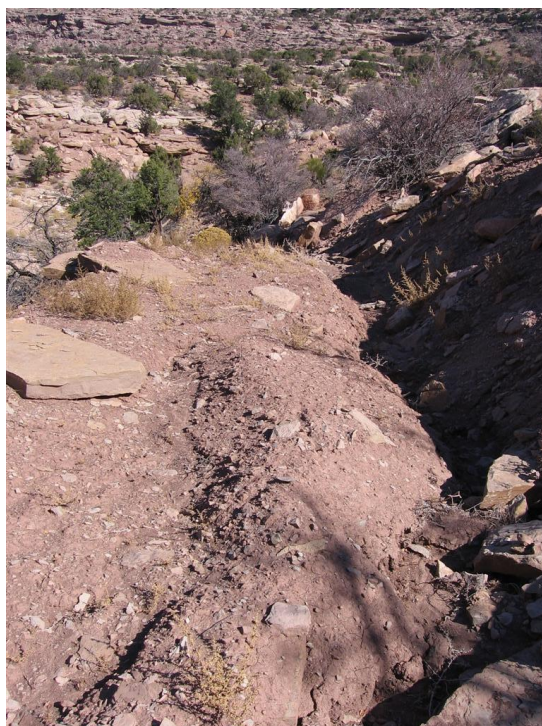
Photo 4. Waste debris and drainage
